# Crane Safety 2003

Chris Oynes  
MMS Regional Director  
Gulf of Mexico

June 24, 2003

**Minerals Management Service**

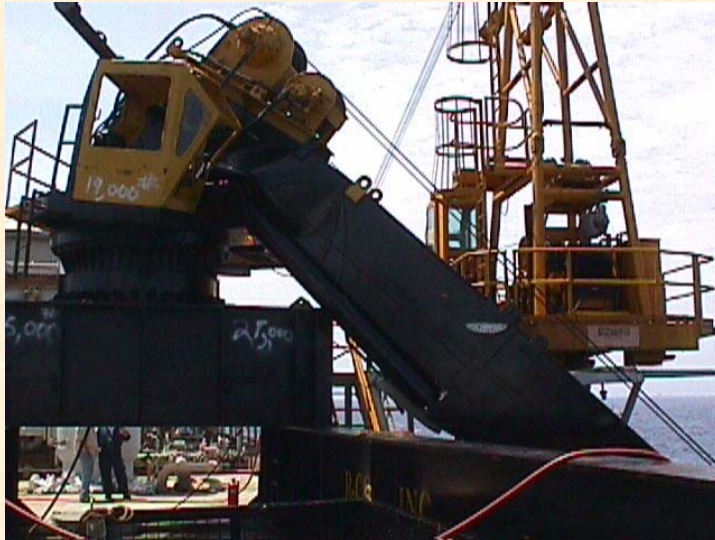
**WC 620**

This 100-Ton crane was being used to lift an 89,000-pound compressor off of a workboat

During the lift a hydraulic hose on the boom cylinder ruptured causing the boom to cradle then fail.

In the course of the investigation, a contributing root cause was determined to be that the failed hydraulic hose was not run in a manner to ensure full unrestricted flow. The hose had a sharp elbow which may have been restricting flow causing it to overpressure.

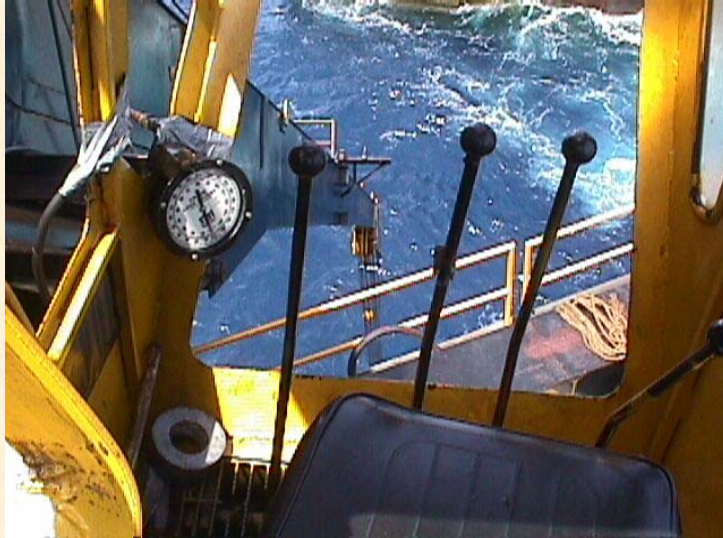
**WC 620**

This is the same 100-ton crane with the view from the operator's seat.

Look at the weight indicator. Do you see the duct tape holding the weight indicator?

The roll of tape is down in the bottom portion of the picture.

Is this an indication of how this rental crane is operated and maintained??

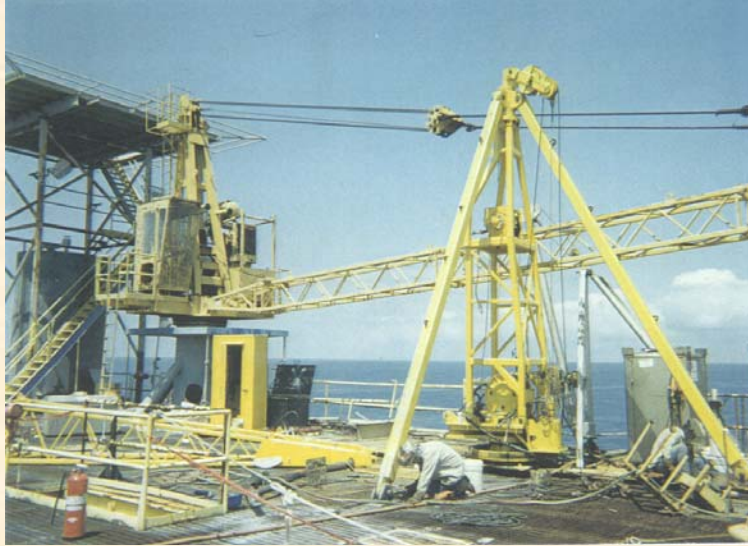
**May 6, 2002**

This particular king-post style crane was not involved in an incident, however, a similar one was involved in an incident which resulted in a fatality.

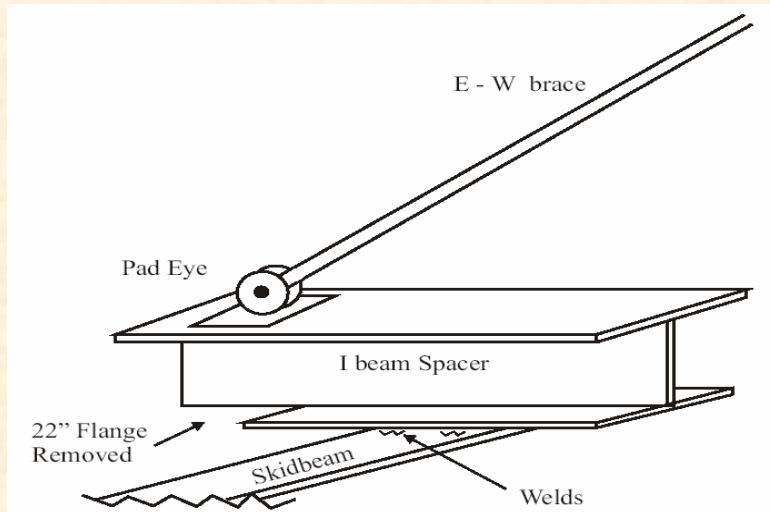
**MP 255**

The crane was installed in a manner where one of the braces was positioned in a cantilevered manner on an additional I-beam.

As the load was swung in the direction directly opposite this support brace, the support brace failed, allowing the crane to strike and fatally injure one of the crew. The crane and the crewmember fell overboard into the water.

During the investigation, it was discovered that no engineering analysis was done on the use of the cantilevered position of the support brace. The investigation also found that there were no procedures for the proper installation of this style crane.

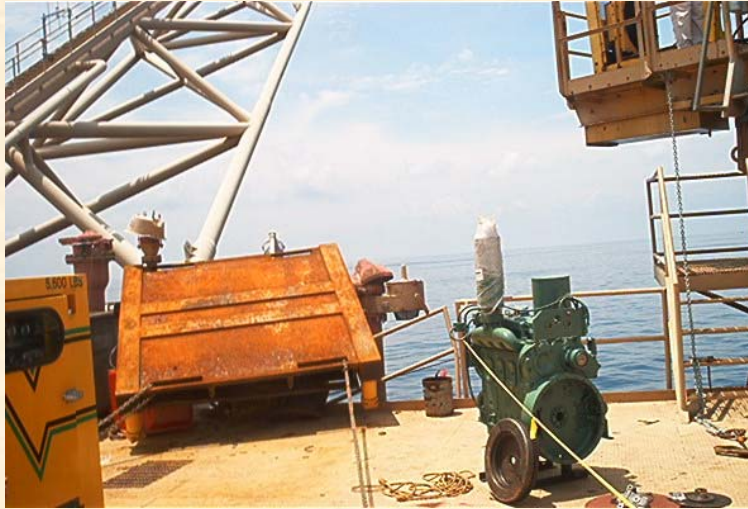
**MP 265**

This temporary knuckle-boom crane was intended to be used to change out the engine on the existing platform crane.

While attempting the lift, the crane fell over, sliding across the deck into the handrail.

The crane came to rest against the handrail with the boom dangling over the side of the platform. The line snapped and the load fell into the gulf.

There were no injuries and the crane was secured to the deck.

The root cause of the incident was that the crane was not properly secured to the deck using the crane's hydraulic locking mechanism.

Other findings from the investigation include that the operator failed to perform an installation inspection, a pre-use inspection, and a load test, and that the platform operator failed to provide the crane operator with the weight of the load being lifted.

There were no written installation and operating procedures for the temporary crane.

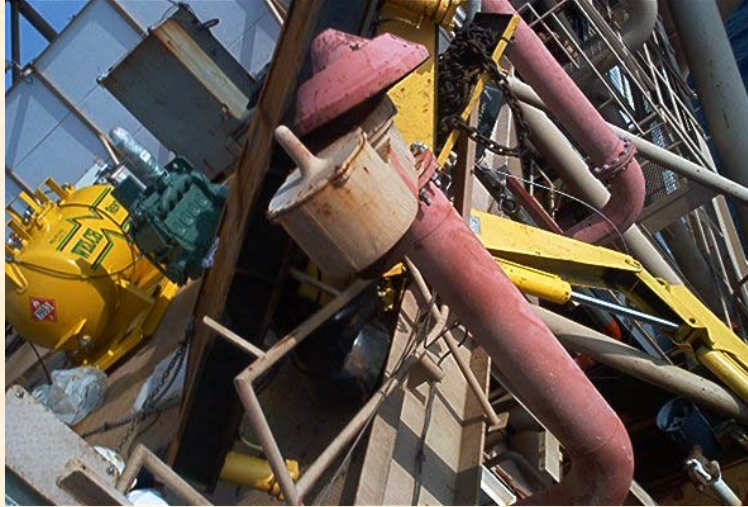
**MP 265**

A different view of the knuckle-boom crane.

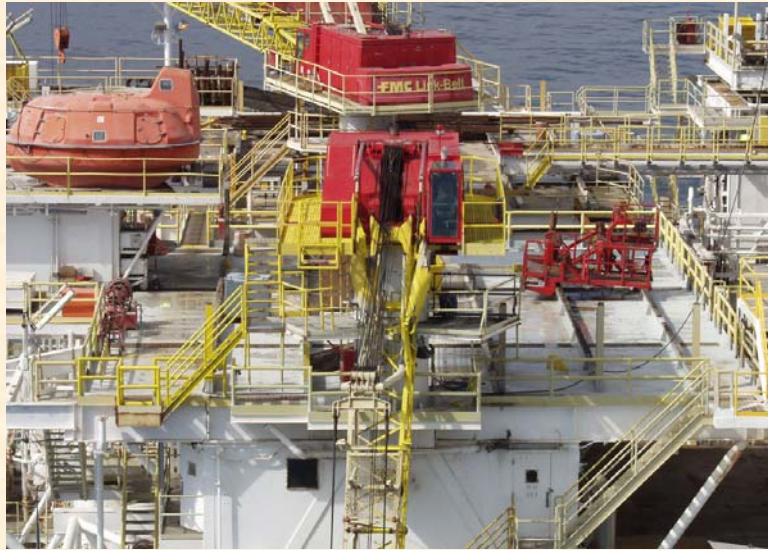
**POCS**

This incident occurred on the Pacific OCS and involved the friction-type crane.

The crane operator was attempting to make a lift when the clutch started slipping allowing the boom to fall and impact the handrail and deck.

This incident is still under investigation.

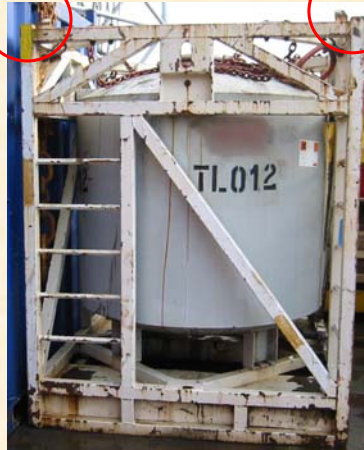
Recently, a person was killed in an accident during a lifting operation on the Norwegian continental shelf.

Two chemical pods had been stacked on top of each other. Preparations were being made to move the upper pod onto the deck by means of the crane. During the lifting operation, the pendant which was not connected to the pod slings, got stuck between the pods frame work and the pod. By lifting the pendant, it snagged the frame causing the pod to slide, and fell down and fatality crushed the employee.

**It is strongly recommended that any container of similar design should not be stacked.**
